REBAM® – getting past the limitations of seismic transducers to a more thorough root cause analysis of a rolling element bearing failure

by Ron Bosmans

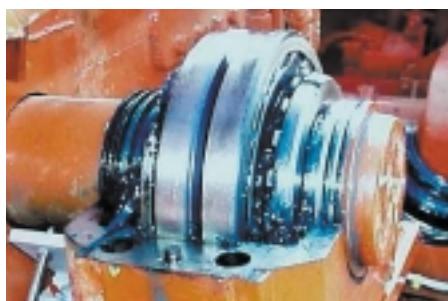
Figure 1a. Double row, rolling element bearing supporting the non-drive-end of the chipper drum.

The REBAM data was used to successfully identify a thrust loading problem on the double row, rolling element bearings that supported the 48 inch diameter, 50 inch long drum (Figures 1a & 1b) that is the heart of the machine. The application is one that demonstrates the unique capabilities of REBAM to provide data beyond the inner race, outer race, and element failure information associated with casing-mounted transducers. The data provided insight to the process and rotor-related problems that were the source of the bearing failure.
